HISTORIC STRUCTURE REPORT

Architectural Data Section

LINDENWALD

MARTIN VAN BUREN NATIONAL HISTORIC SITE

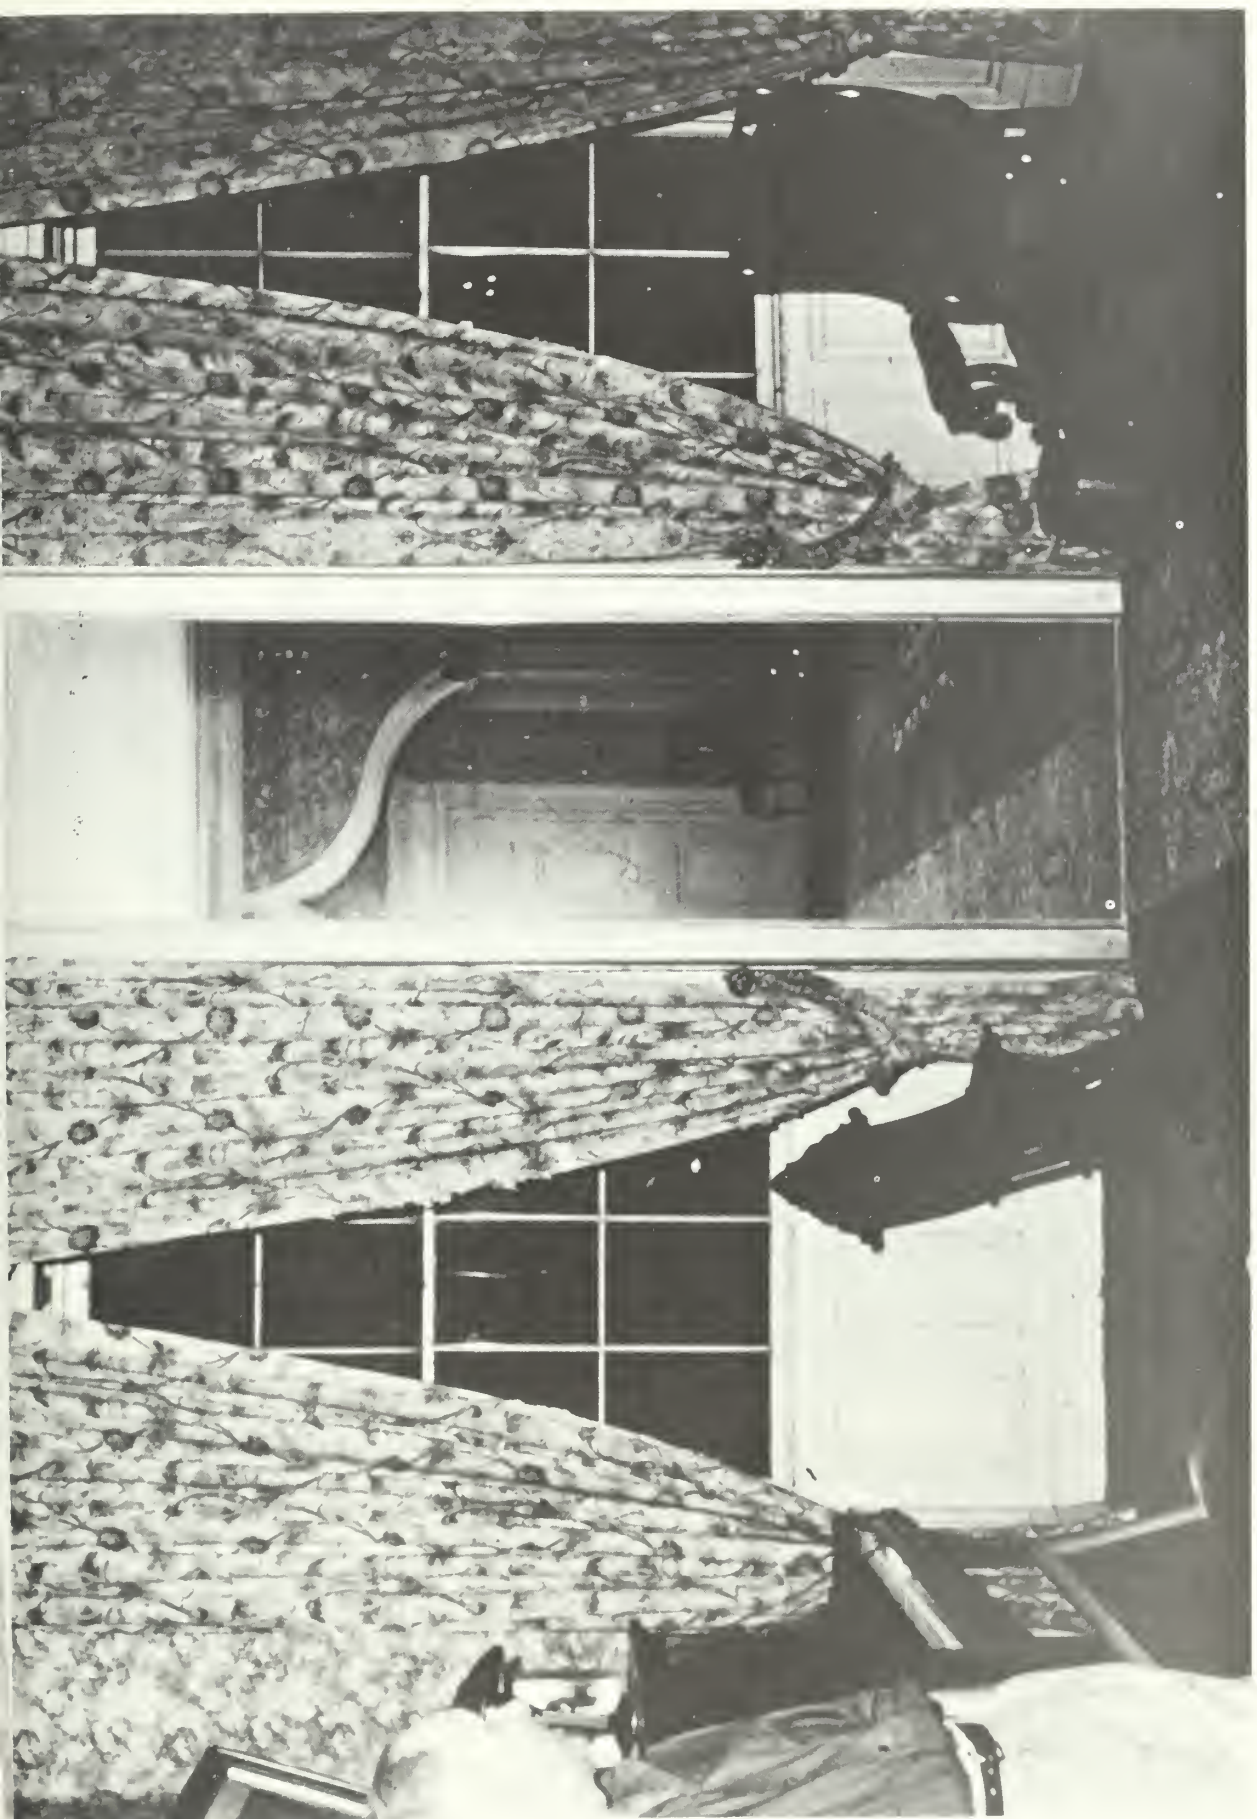
HP40. Room 106, ca. 1936-1957. This photograph is associated with HP38 and HP39 and assigned a date of ca. 1936-1957 on the basis of circumstantial evidence presented with HP38. The following details should be noted:

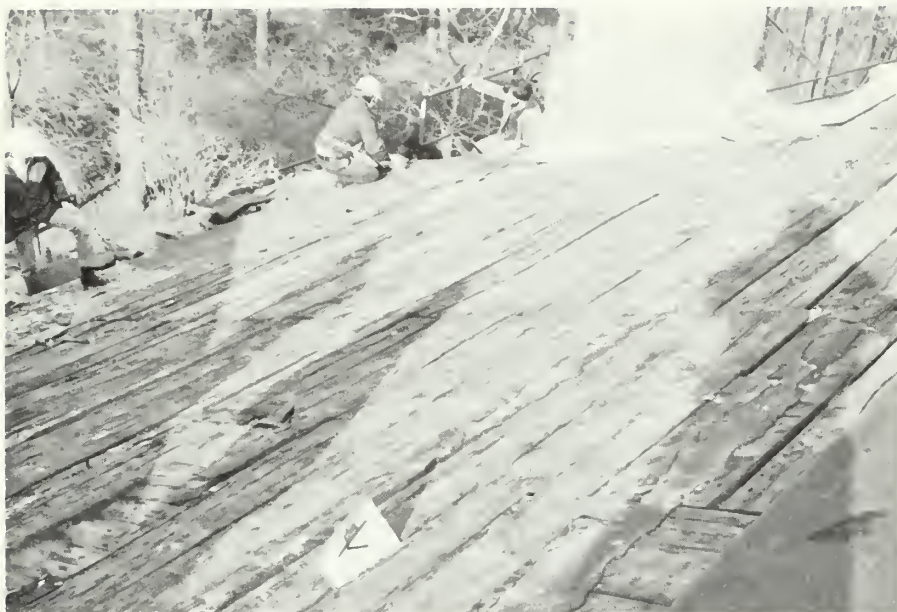
IP003, N039-01. Main roof, northwest corner looking northwest. Note hatch infill in foreground.

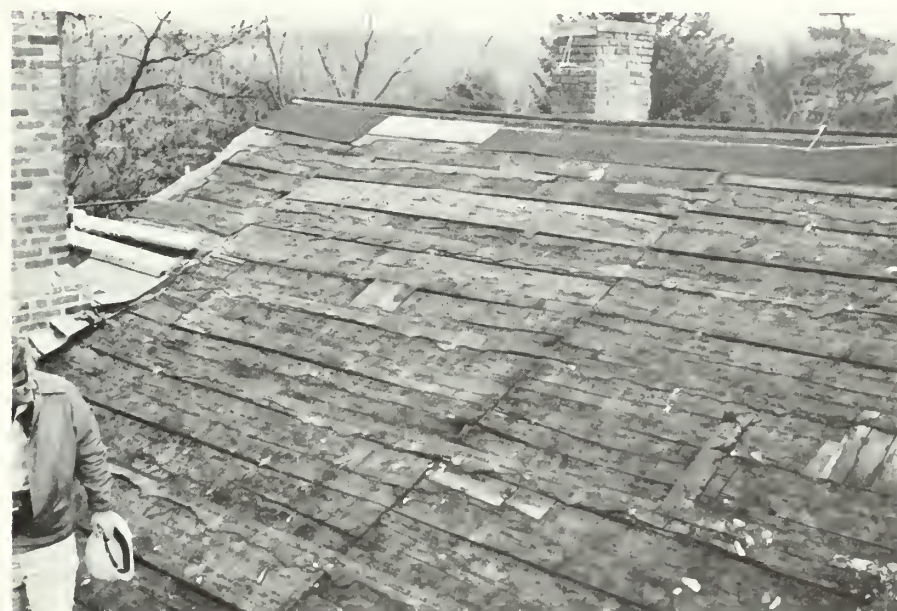
IP004, N039-07. Main roof, northwest corner looking northeast. Note shingle shims.

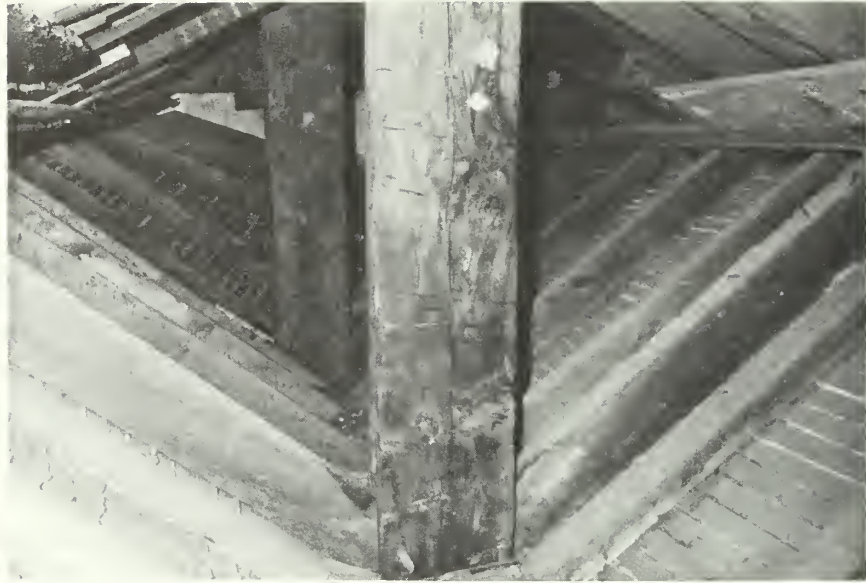
IP005, N002-11. Kingposts above ca. 1849 ceiling. Note plaster on end wall.

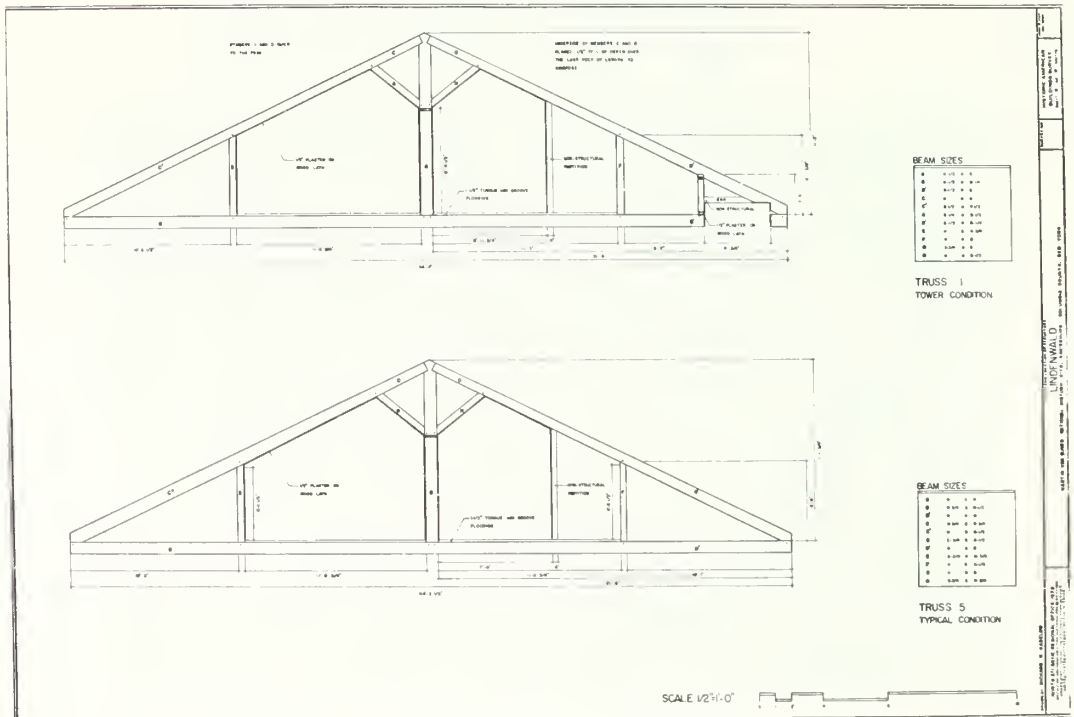
IP006 (microfilm card). Elevation of typical truss-like configuration of ca. 1797 roof rafters.

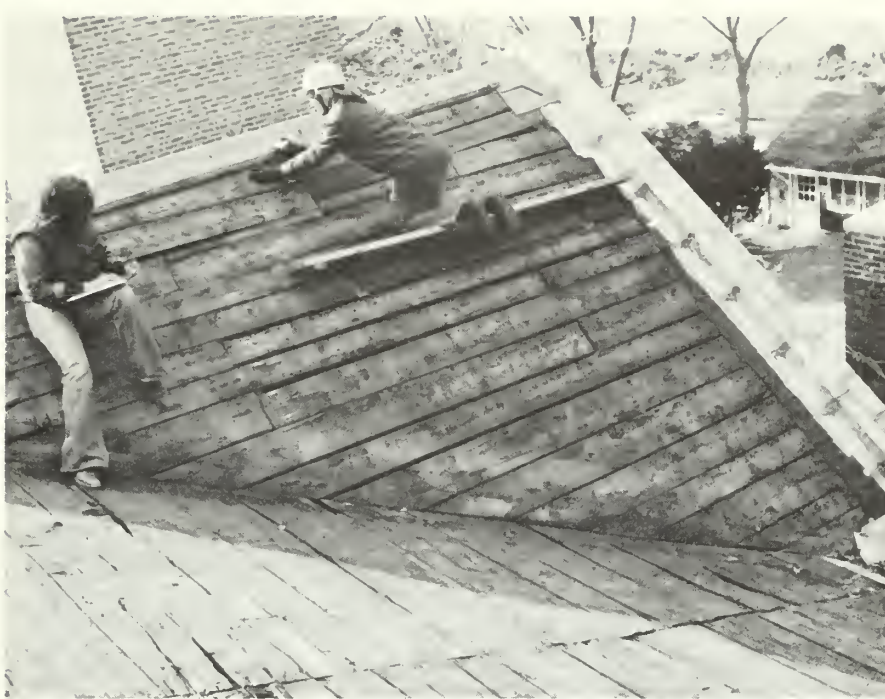
IP007, N039-14. Gable sheathing.

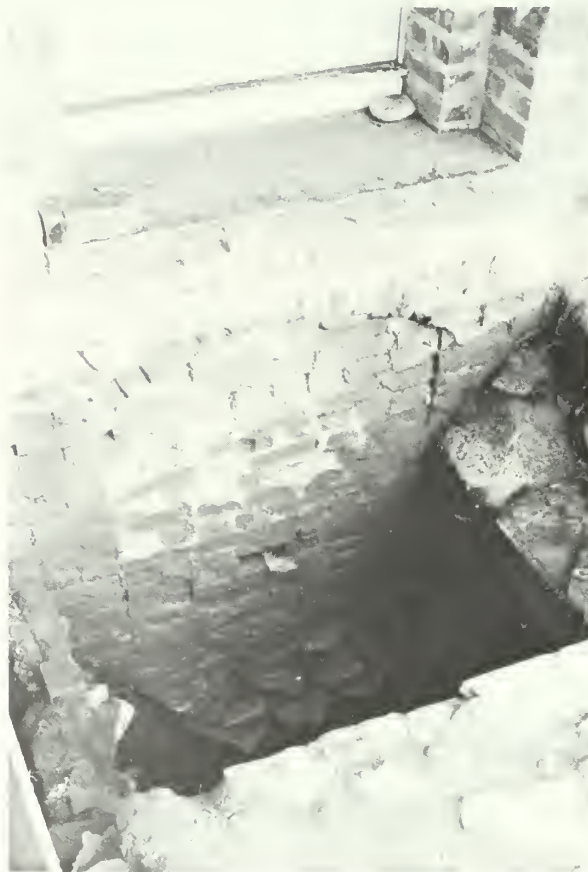
IP009, N004-19. Exterior view of door 010, probable entrance to cold storage area.

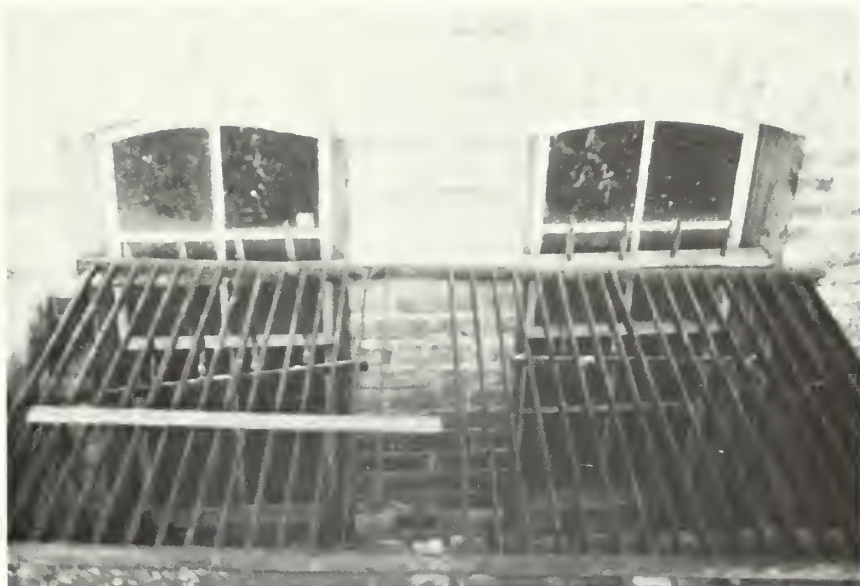
IP010, N019-14. Window well 012-13.

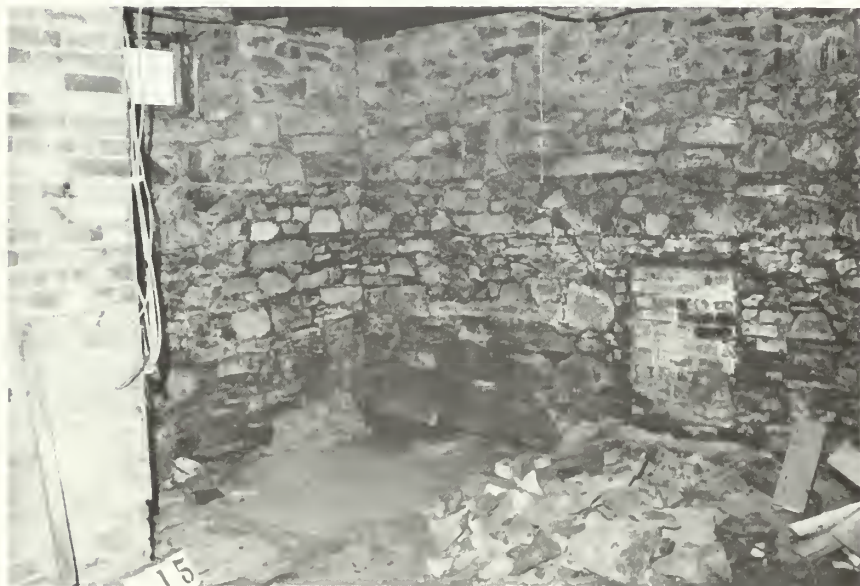
IP011, N016-12. Room 015. Note bricked-in coal chute opening.

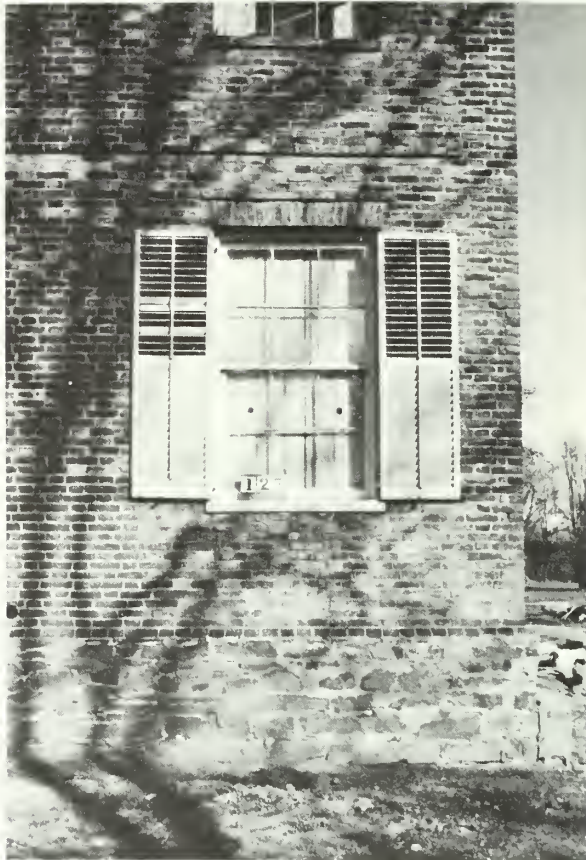
IP012, N012-08. Window 127, typical ca. 1797 window with ca. 1840 sash and shutter blinds.

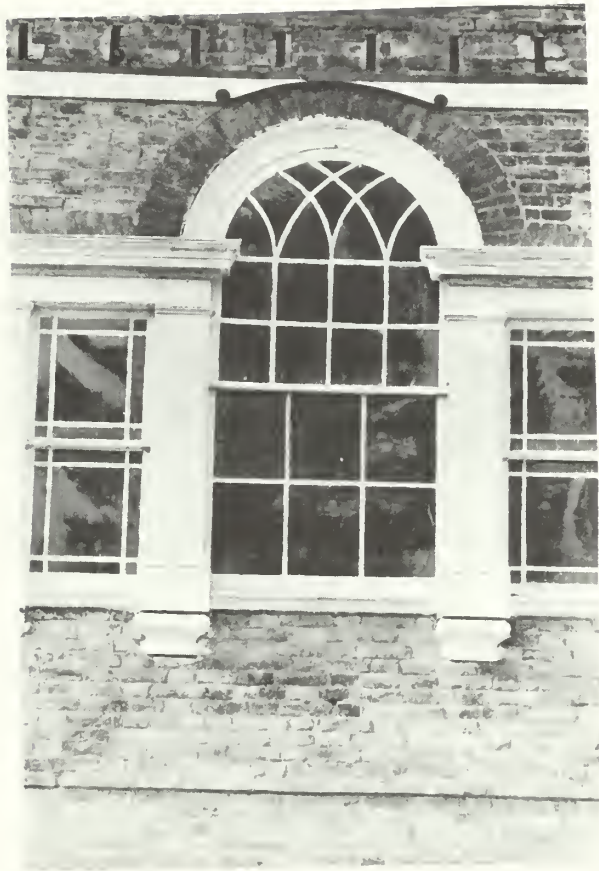
IP013, N013-05. Window 204, ca. 1797 "Gothick" sash above ca. 1840 six-light sash.

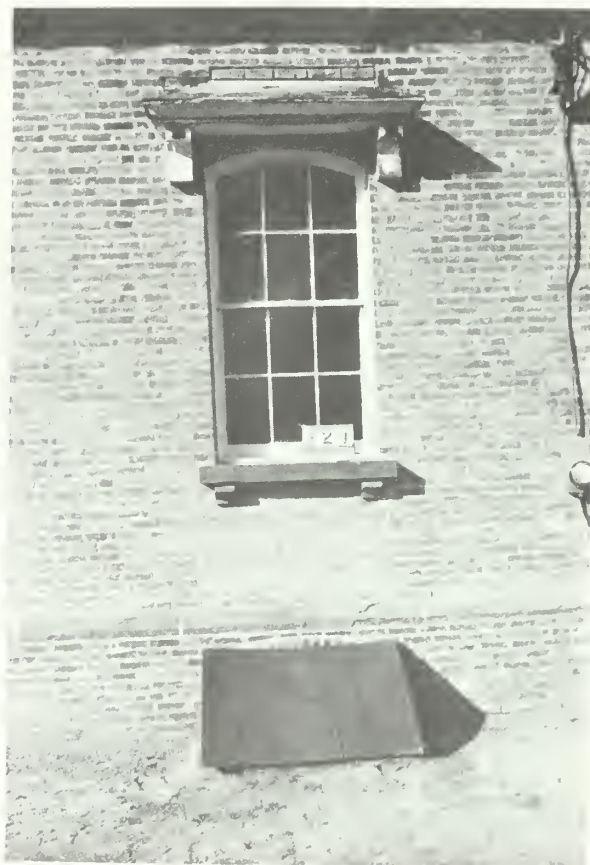
IP014, N012-05. Window 124, typical ca. 1850 sash.

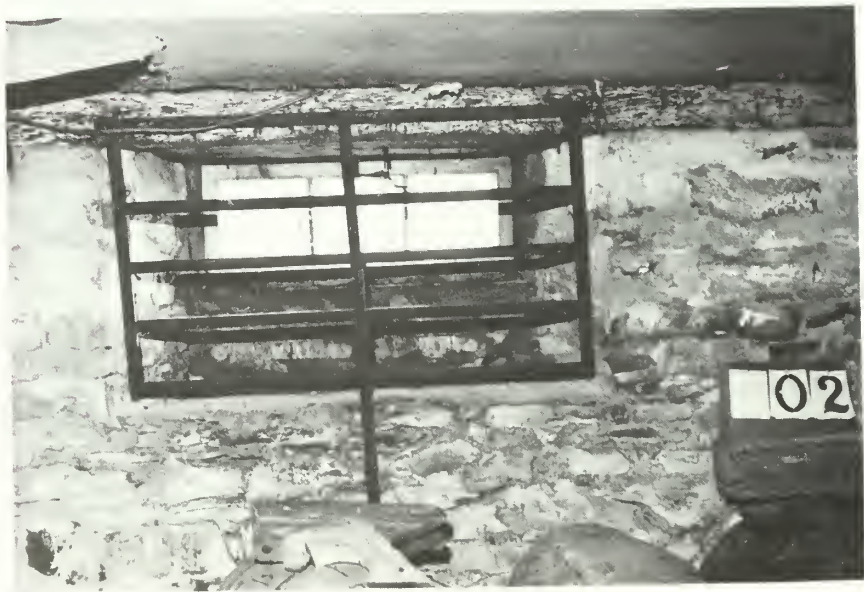
IP019, N011-14. Room 003A, west wall, south end, window 026.

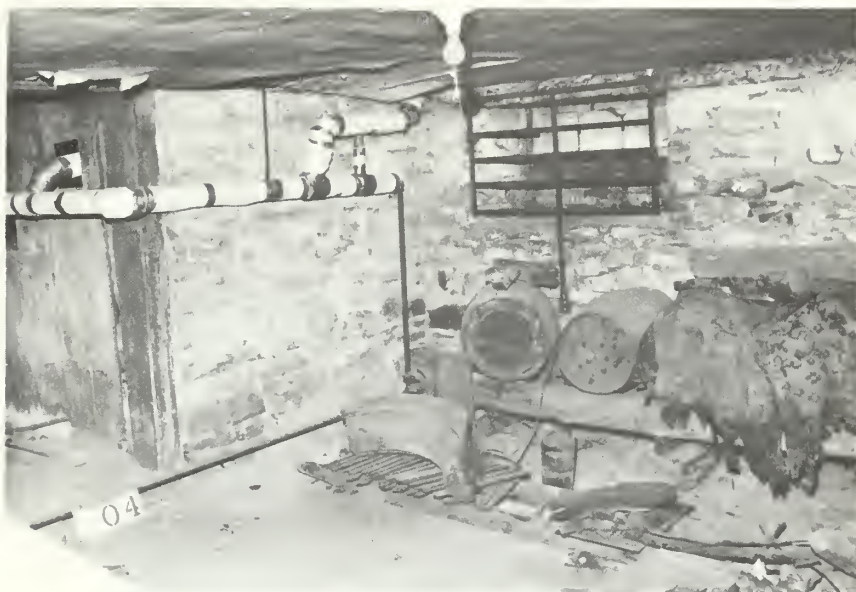
IP020, N010-19. Room 004, window 002 with iron bars.

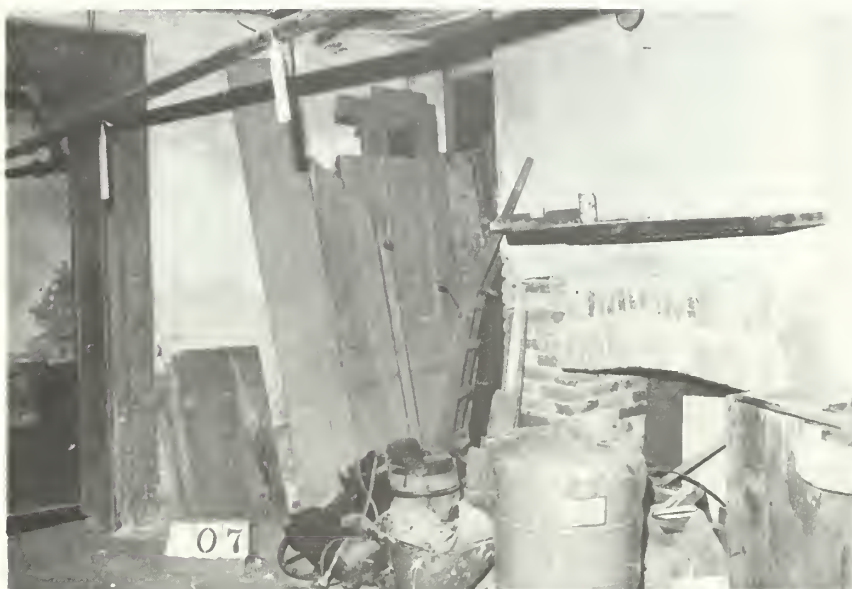
IP021, N007-30. Room 004, northeast corner. Note barrels on rack and porch pieces on floor.

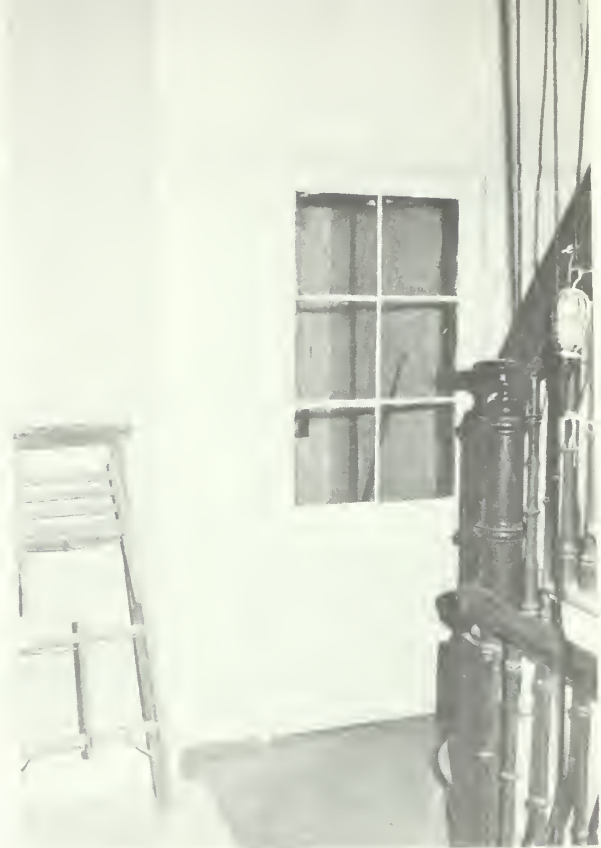
IP035, N025-35.
 Room 113, north wall.
 Note board partition and
 door 121.

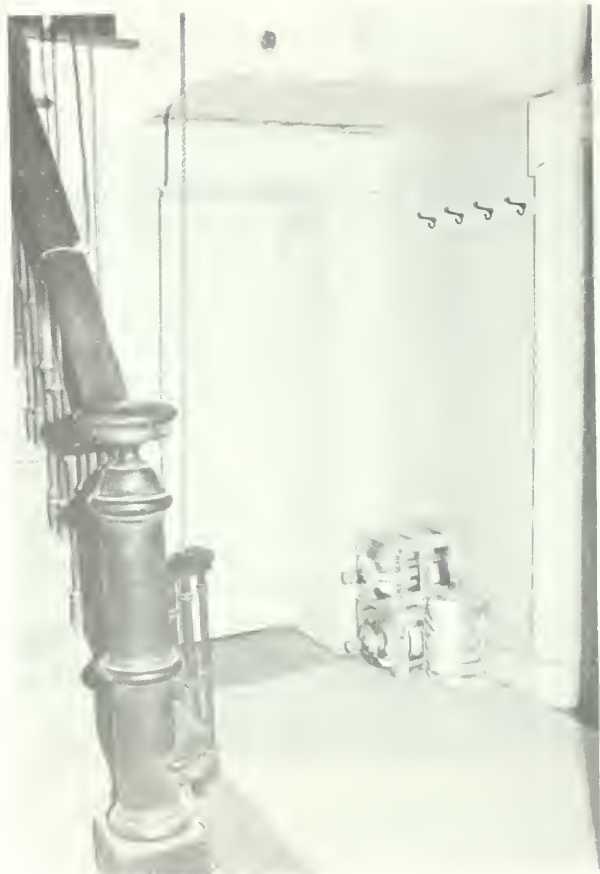
IP036, N025-33.
 Room 113, southwest corner.

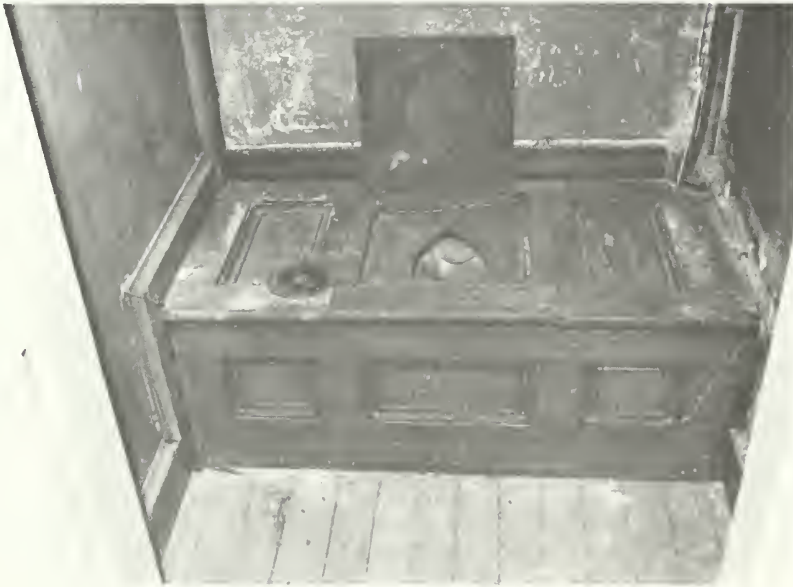
IP037, N021-01. Room 114, southeast corner, fireplace. Note mantel and oculus window (W131).

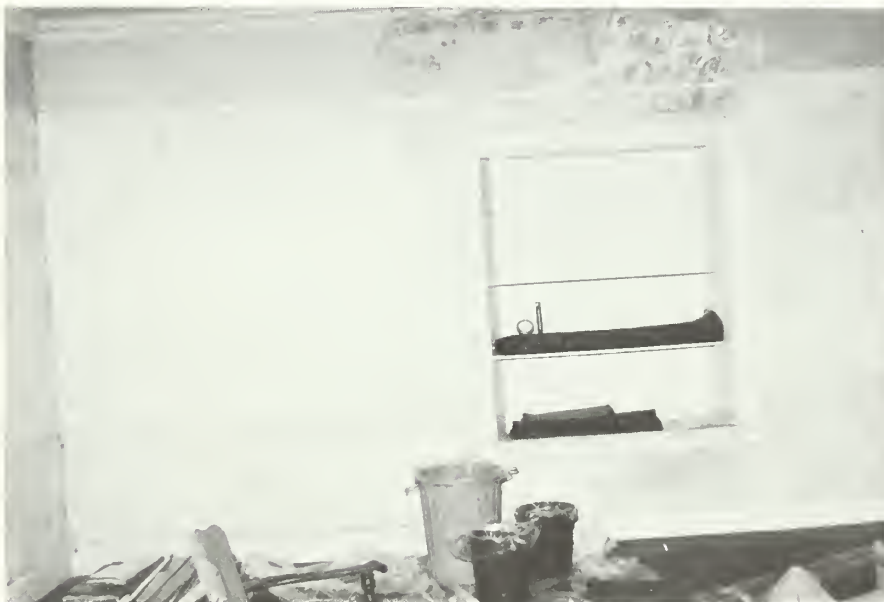
IP041, N023-02. Room 121. Note similarity to water closet (IP034).

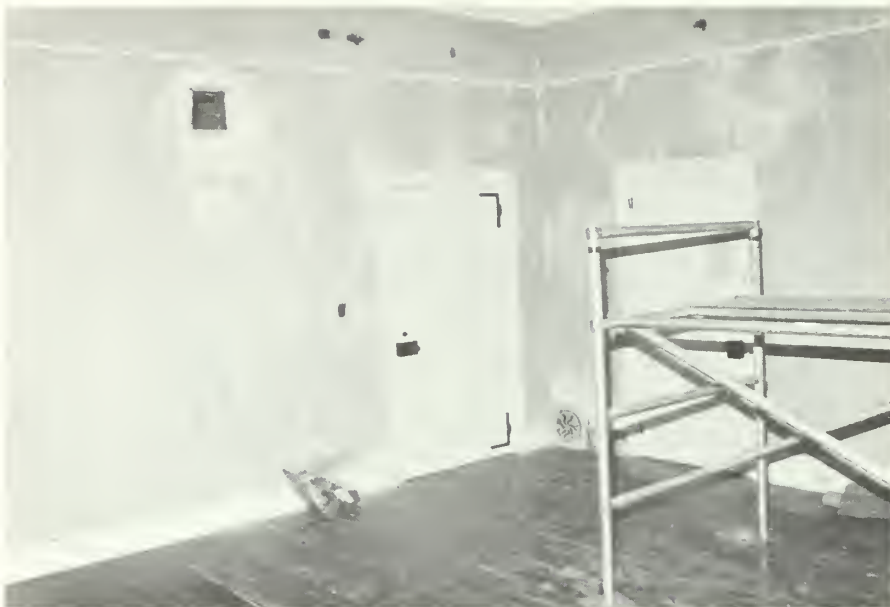
IP042, N030-37. Room 201 west wall. Note shelves in former window opening.

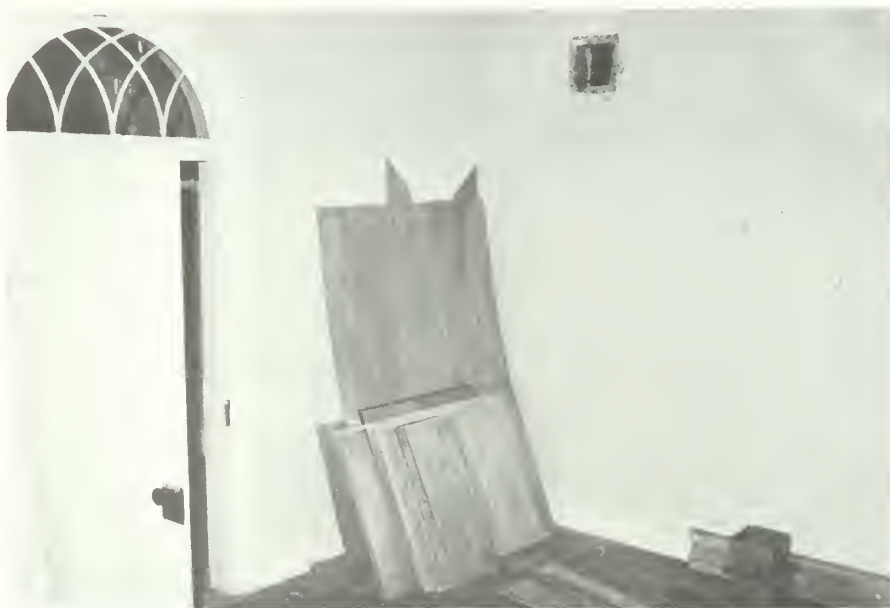
IP043, N030-31. Room 205, south and west walls. Note outline of former door opening (door 219) on south wall and ventilation opening above.

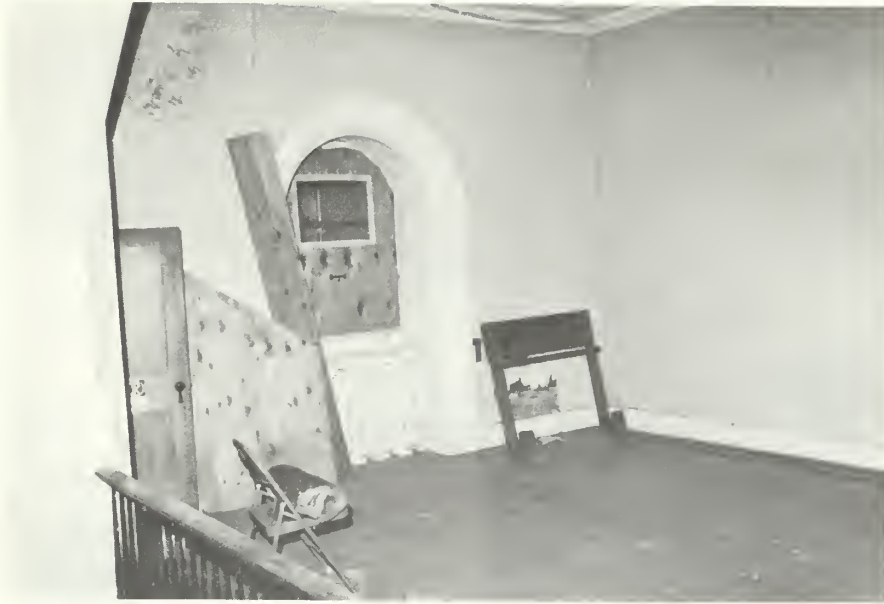
IP044, N030-23. Room 208, northwest corner. Note faint outline of former door opening (door 219) on north wall below ventilation opening and patch of chair rail across door opening.

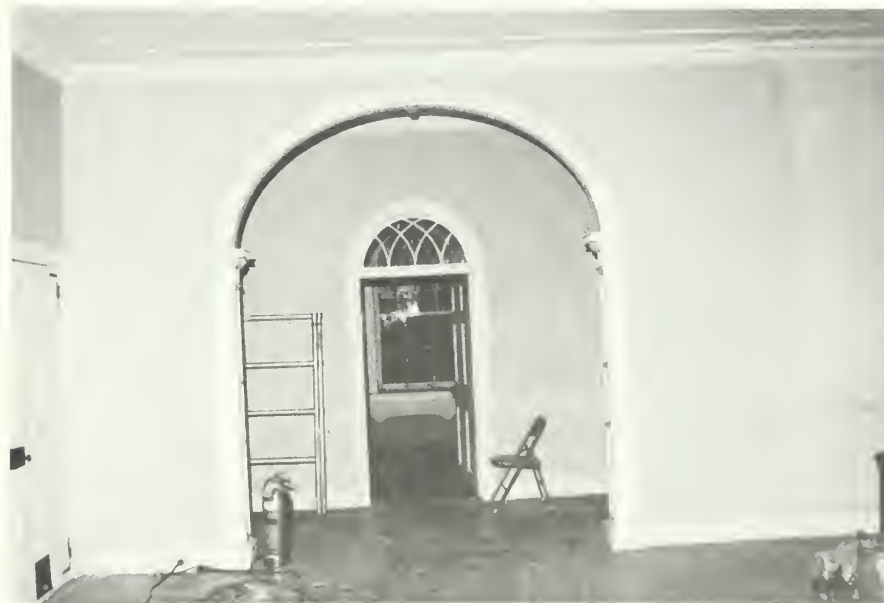
IP045, N029-36. Room 206, west and north walls. Note window 213 and balustrade.

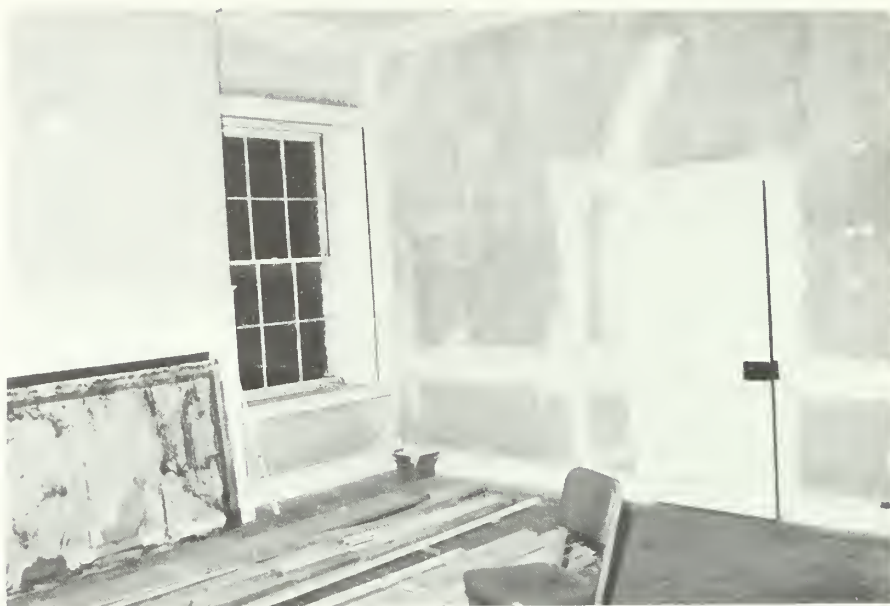
IP046, N030-03. Room 206, looking east into rooms 207 and 208 through doors 218 and 202. Note vertical line at former location of south wall near right edge.

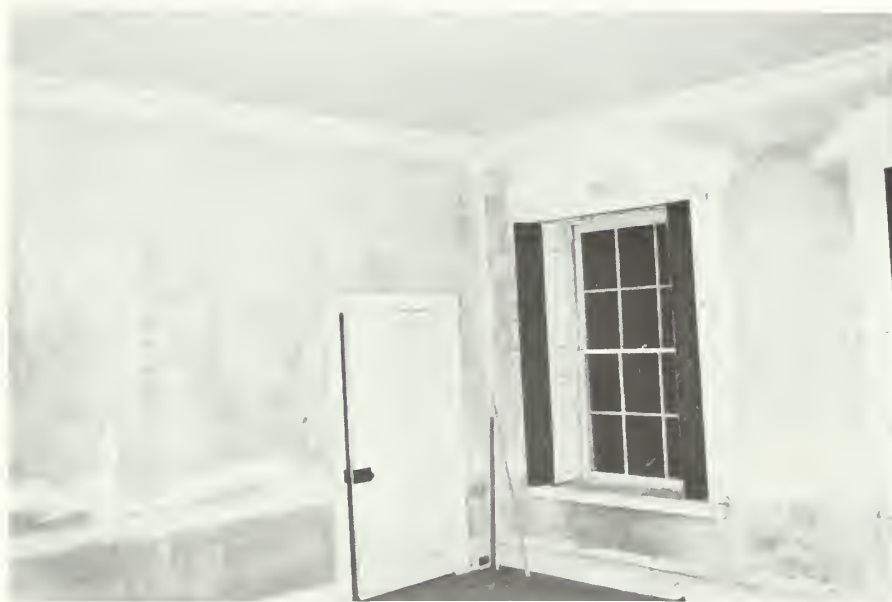
IP049, N030-29. Room 208, west wall, door 202.

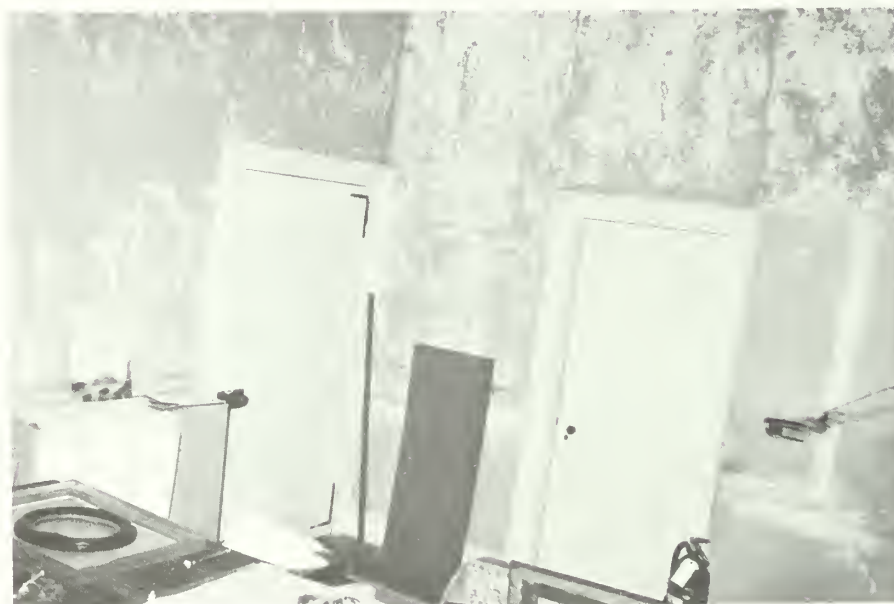
IP051, N029-34. Rooms 206 and 110, looking west down stair.

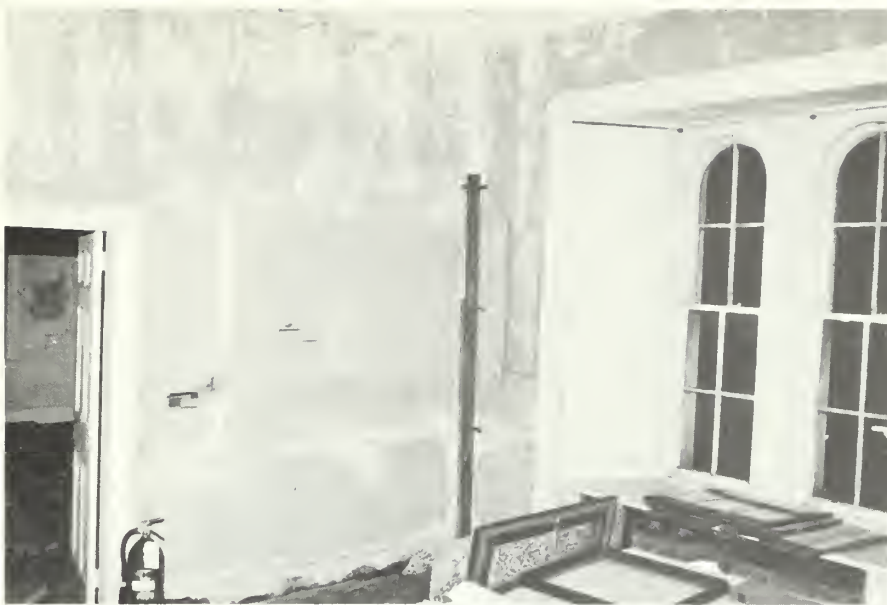
IP052, N030-11. Room 210 north and east walls, doors 215 and 216.

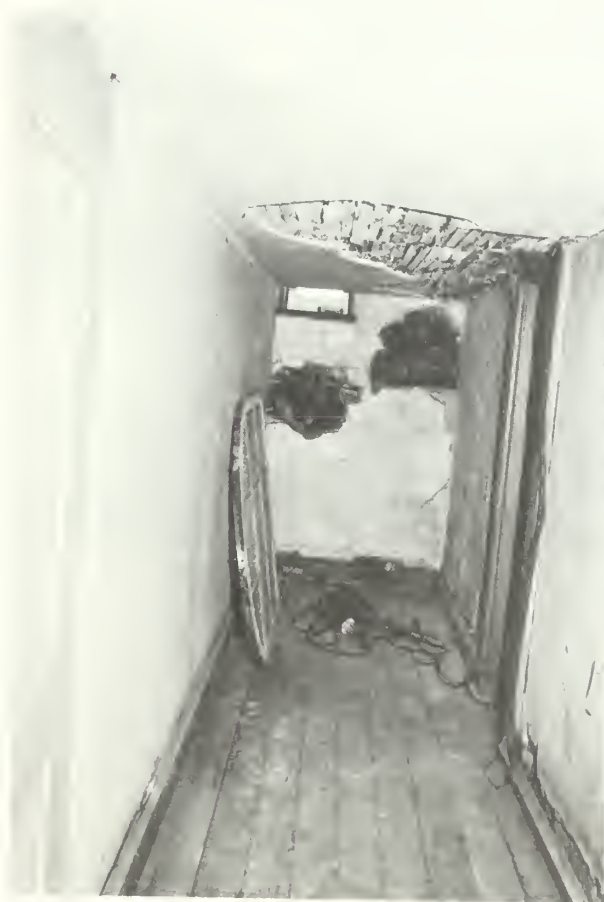
IP053, N030-10. Room 210, east and south walls, door 216, and windows 215 and 216.

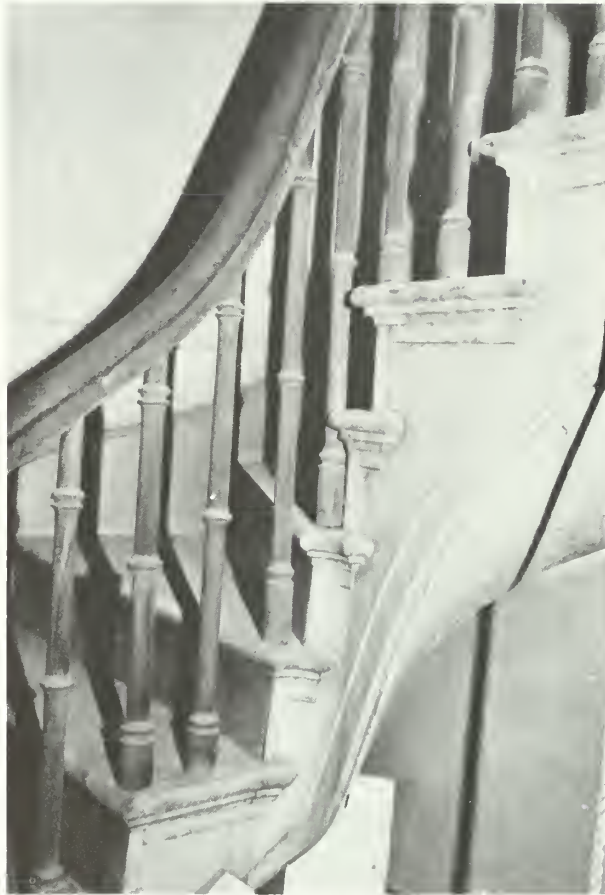
IP055, N031-17. Room 212, detail of tower stairs.

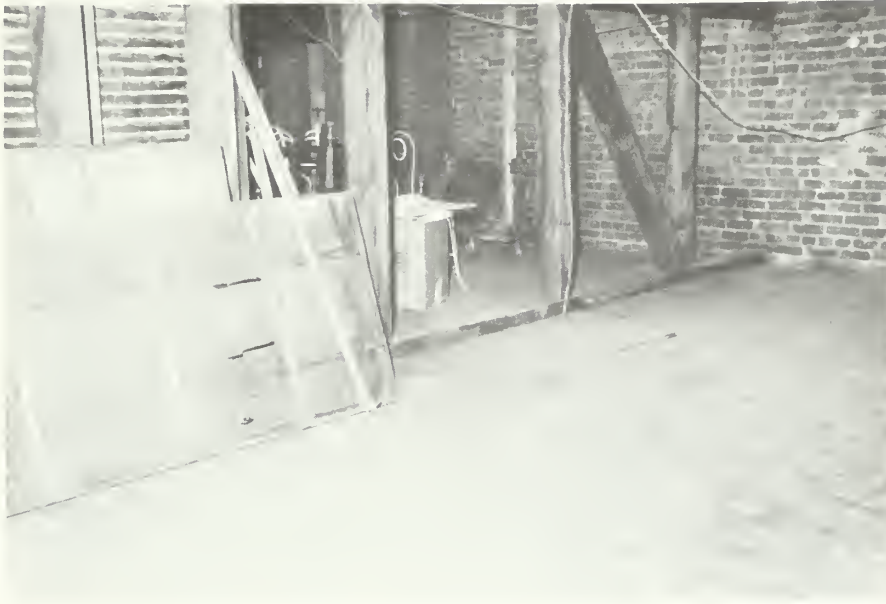
IP056, N031-24. Room 213, looking southeast, with monitor skylight framing on left, brick tower on right, and east roof truss across view.

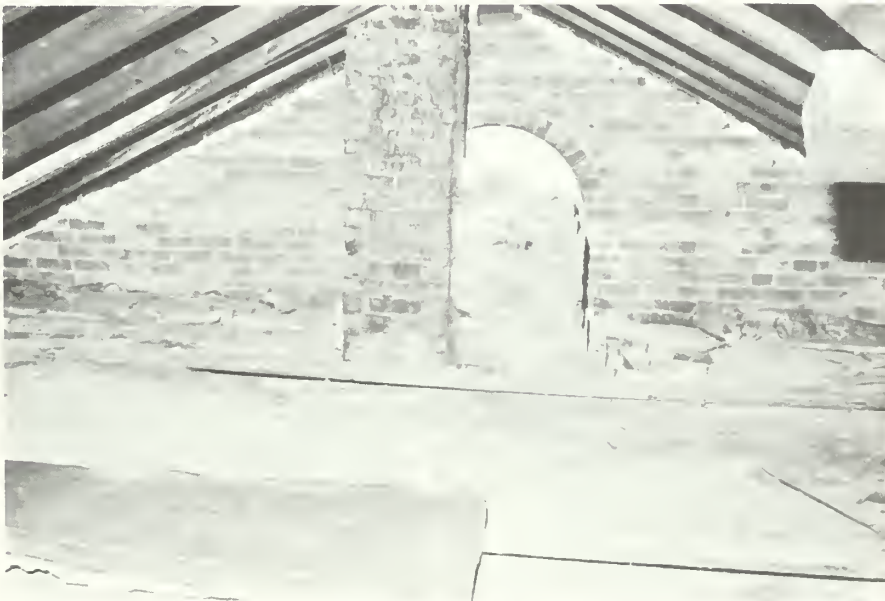
IP057, N031-26. Room 213, over room 112. Note brick chimney and window 214.

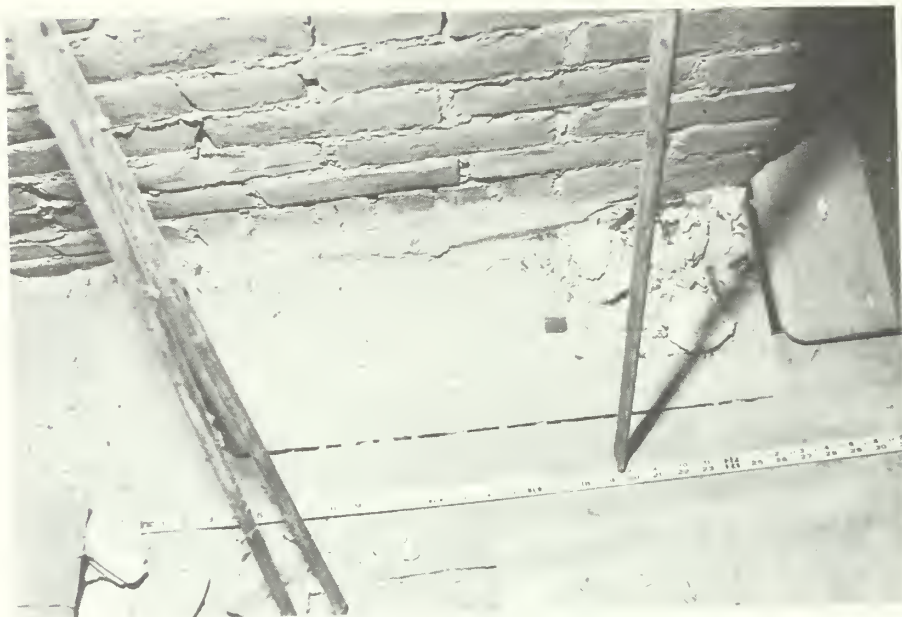
IP058, N031-27. Brownstone splashblock reused in tower masonry at floor level of room 213.

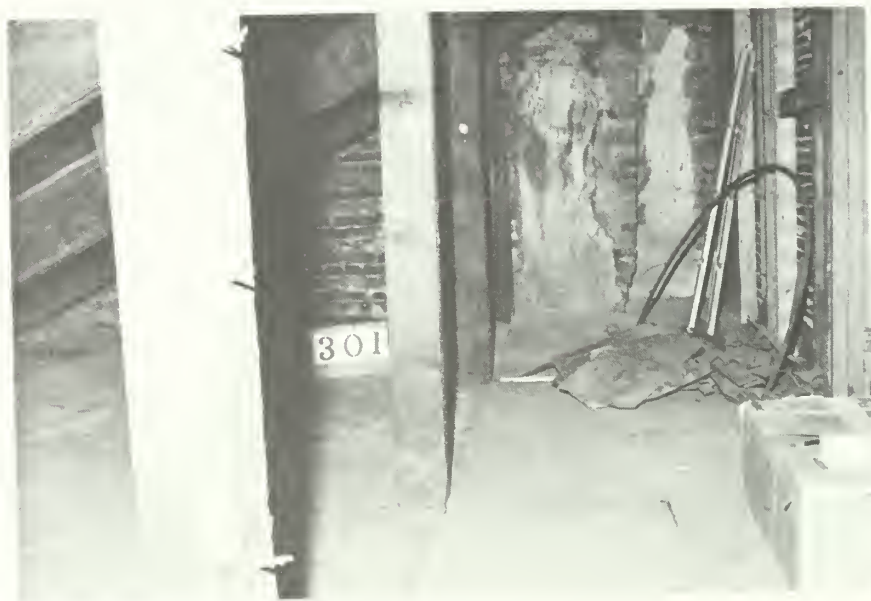
IP059, N006-32. Room 301, looking north to plastered gable end, with knee braces to the left. Note T-head wrought nails in nearest knee brace.

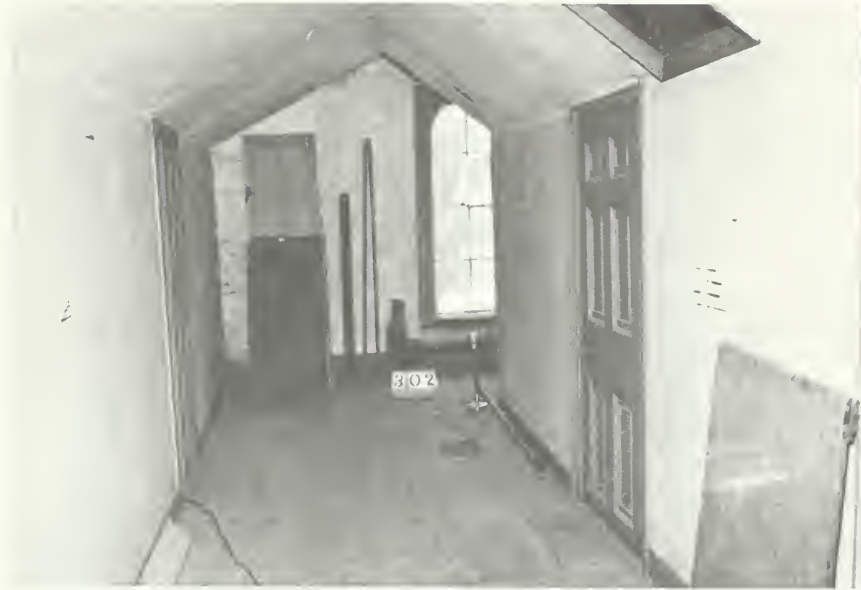
IP060, N008-08. Room 302, looking north past door 305 on the right and 306 on the left to window 305. The faint outline of the former stair opening can be seen near door 305. Note also the floor register and the hatch opening to the ridge space.

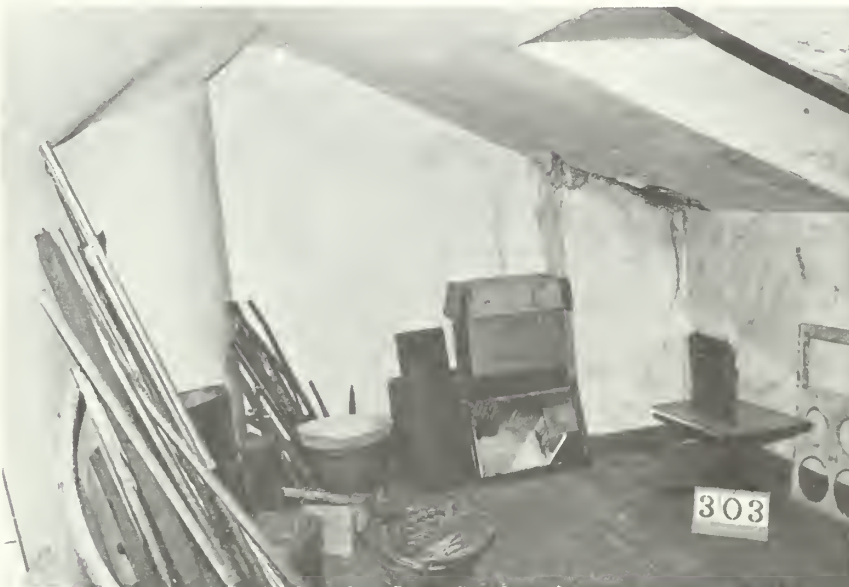
IP061, N008-11. Room 303, looking north. Curve at left was made to provide light from window 305 to room 302. Faint outline of former window 304 can be seen on north wall.

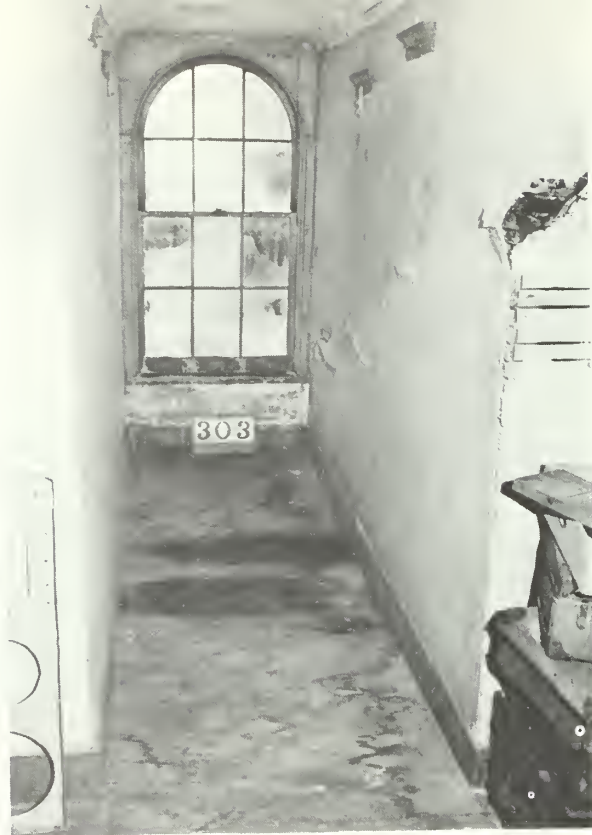
IP062, N008-15. Room 303 eastward dormer extension and window 303.

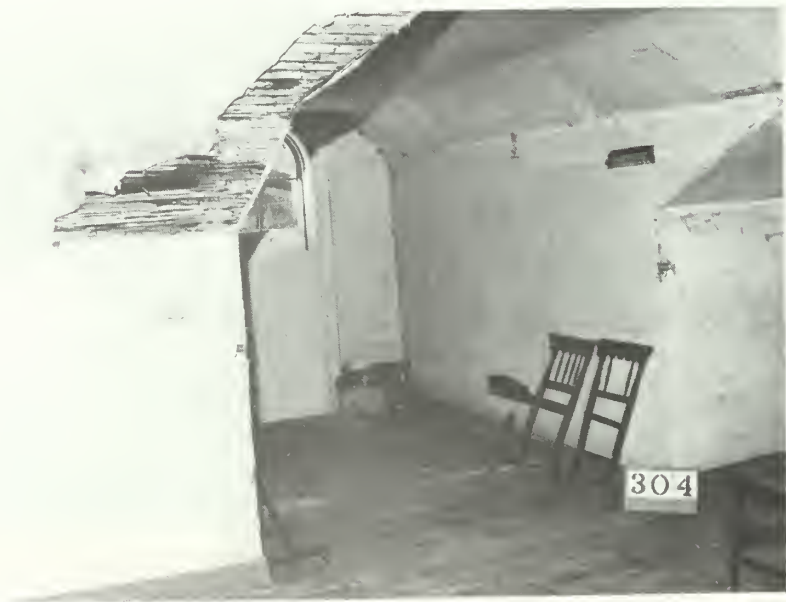
IP063, N008-17. Room 304, looking east into gable extension and window 302.

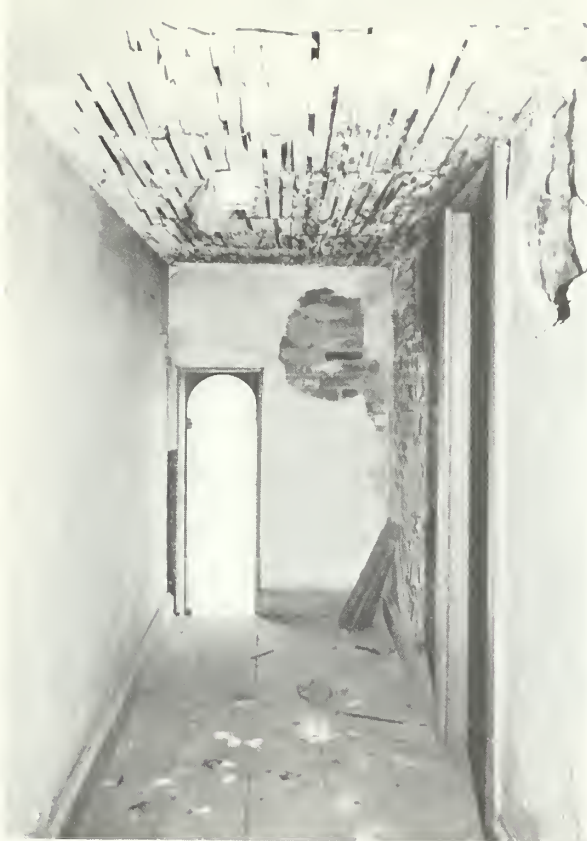
IP064, N032-6. Room 307,
looking south
past door 309
to window 315.
